PARKSIDE

MINTON HOLLINS

MINTON HOLLINS CERAMIC RANGE

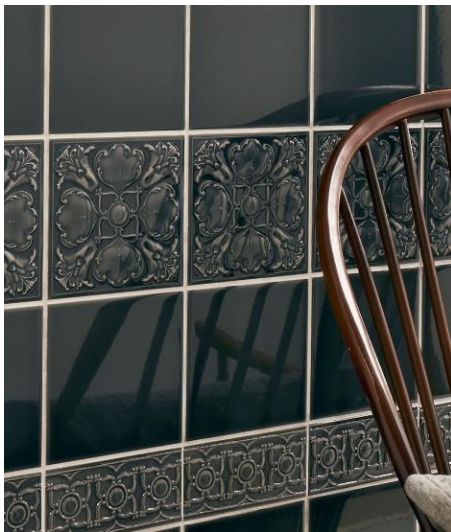
SPECIAL PIECES

Skirting
150x150mm

Border & Capping
75x150mm

| Available Sizes |
|---|
| 150x75x2.2mm – Capping 150x150x1.7mm - Skirting 150x75x9.5mm - Border *Depth varies between plain & décor tiles. |
